The Medieval Grange of Cuna – Siena (Italy)-Interdisciplinary Studies on Masonry Structures

Abstract. A team of specialist in different subject worked together with a multidisciplinary approach for the conservation of the complex of the Grange of Cuna, the administrative and storage center of the bigger farm of Santa Maria della Scala Hospital in Siena (Italy) in Middle Ages. Laser scanner surveys, archival and bibliographic researches, stratigraphic surveys, structural surveys were carried on and studied by the members of the team on the complex of 167 rooms. The results obtained by specialist approach was frequently discussed and compared in order to obtain a deeper knowledge of the complex of buildings. Structural engineer studies concerned the identification of different typologies of masonry and the structural diagnostics to mechanical characterization. Double flat jack and sonic inspection were performed on tapial adobe, brick masonry with lime and mud mortar.

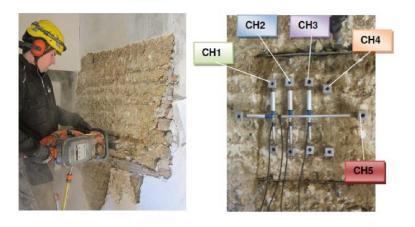
One double flat jack was realized on tapial adobe wall, showing. during the final test phases, many vertical cracks and sub-horizontal cracks close to the jacks. It has to be underlined that these types of tests are seldom carried out on tapial. Results are reported in the following (Figs. 2 and 3, Table 1).

Fig. 2. Double flat jack on adobe set-up

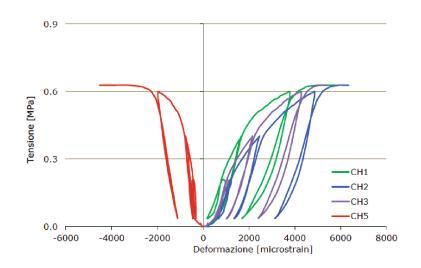
Maximum measured stress was equal to 0,60 N/mm², being cycle load increased at a rate of 0,20 N/mm².

Fig. 3. Tension-deformation of single channel for double flat jack on adobe

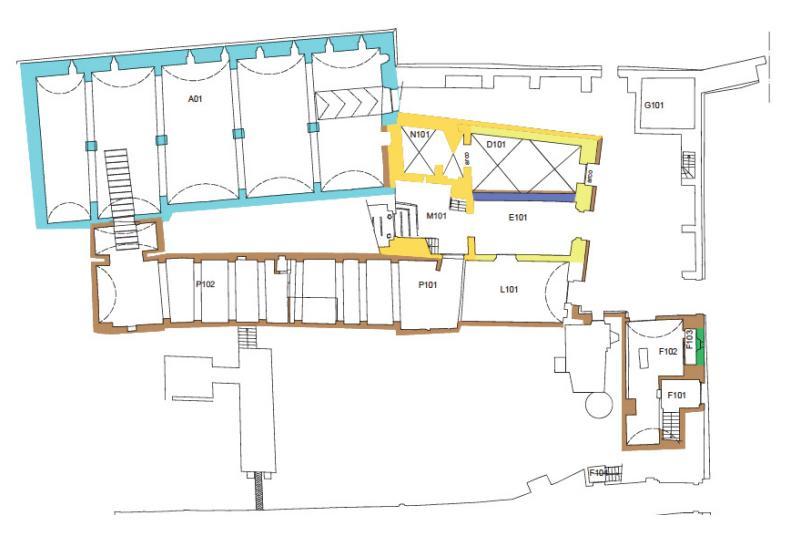
Fig. 4. Level 0

Main results on double flat jacks and sonic inspection are reported in Table 2 in which the number of phases is not reported in chronological order. In Figs. 4, 5, 6, 7 and 8 the mapping of each phase is represented in different colors.
