PRESERVATION OF XX CENTURY RESTORATION:

THE CASE OF PORTA VESCOVO IN VERONA

E. Manzoni¹, A. Sandrini², A. Dusi¹

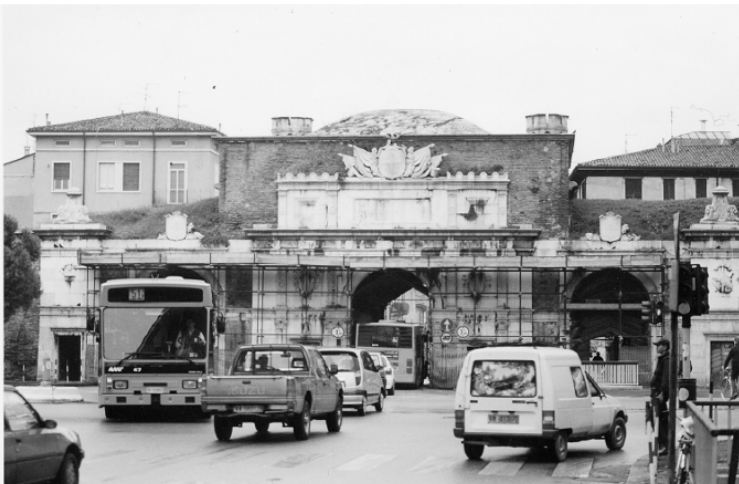
Picture 1 Porta Vescovo today-countryside

Porta Vescovo is one of the main gate to the ancient city walls of Verona. (Picture 1)

Historical documents date the construction of Porta Vescovo in 1520, even if it seems that the works already started in 1517. The 1500's gate is a solid brick parallelepiped, with a cubic shape covered by a four pitch roof.

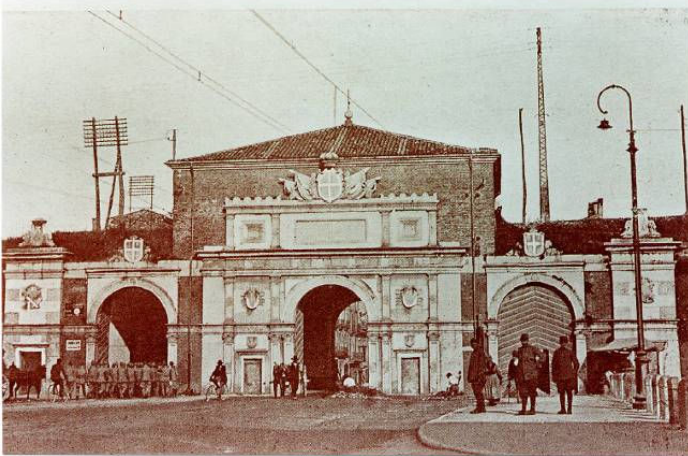
Picture 2 Porta Vescovo in XIX century -countryside

Between 1862 and 1863 Hapsburgs need a new cart way access to the hearth of the city and they change the shape of 1500 Porta Vescovo. In 1860, two lateral one store buildings are constructed, two new little towers and battlemented top are put on the outer side, but the roof pitches still remain untouched.

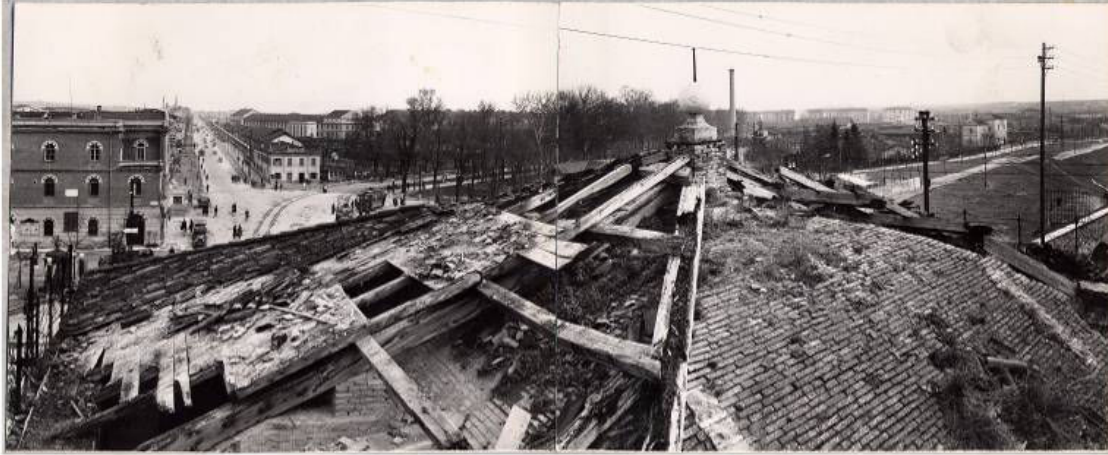
Picture 4 Demolition of timber roof in 1920-1930

Several researches were carried out in the archives of the city and of many Bodies, in order to find documents about the XX century intervention on Porta Vescovo, but only some pictures taken during the demolition works have been recovered. (Picture 4-5)

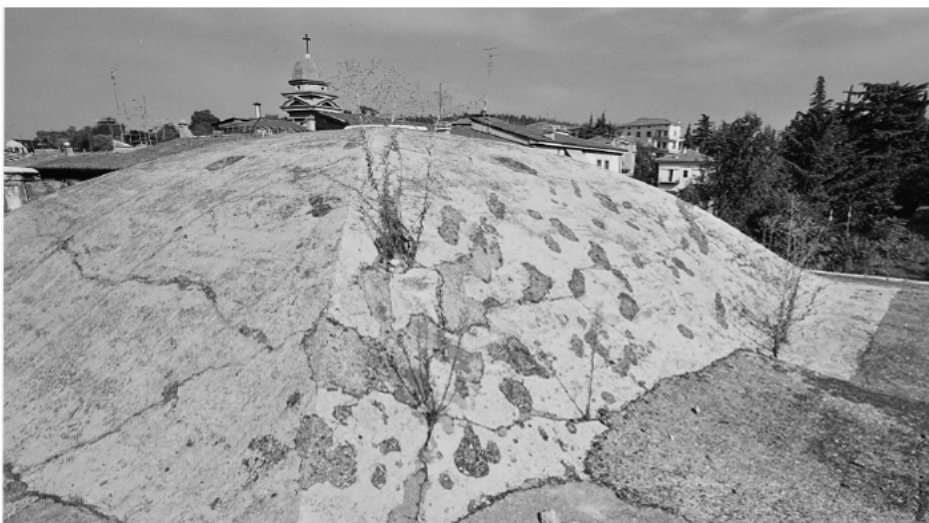
Picture 8 Concrete slab outer view

The damage evaluation also shows that today the concrete slab brings evident signs of degradation, presenting large cracks and also lacunae. From the cracks, water entered in the concrete and got in touch with the steel causing the oxidation of the inside reinforcement. The volume growth of the steel due to the oxidation broke the concrete and caused the collapse of some parts of the plane slab.

Concrete rain pipe are positioned near the battlemented top and they also show evident signs of damage, as discontinuities and holes. From the cracks on the vault, on the plane slab and of the rain pipe, rain and water enter in the lower structure and damage brick masonry and also the facades finishes. (Picture 8)

Finally slab upper surface is covered by a green patina.

The damage is due to the lack of compatibility between the preexisting structure and the 1920 intervention and to the bad execution of the concrete work, but also to the air pollution.³

The concrete slab will be completely removed, but the bond beam. The bond beam will be corrosion inhibited, consolidated and the lacunae will be refilled in order to preserve it and to use it as a support for the new laminated timber roof and to maintain a bonding effect. The timber structure will only lean on the concrete bond beam without any kind of interaction with the masonry vault.

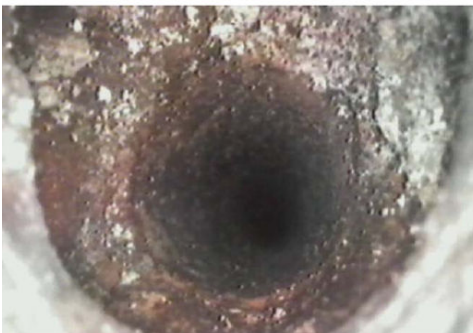
Picture 11 Endoscope test

Three holes 12 mm diameter were made with chain feed rock drill to discover both the presence of holes and the bricks and mortar consistence and thick. A flexible optical fiber videoendoscope, 8.4 mm external diameter, was used.

Endoscopies picture from the top of the cover shows that in the center of the vault the concrete slab is 5 cm thick and masonry vault is 57 centimeter thick. (Picture 11)
